Budapest University of Technology and Economics
Faculty of Civil Engineering

Building vulnerability assessment of historic building in Budapest to define the stages of seismic fragility

Student: Nino Tabatadze
MSc student

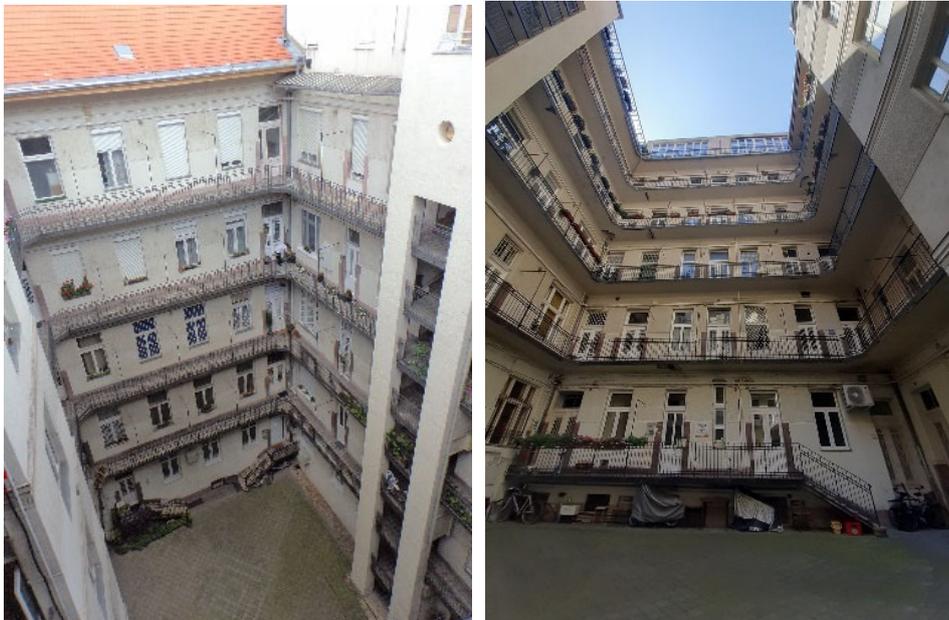
Existing structure is residential building, located in the city center. It was built in 1907. Shape of the structure is rectangular and has vertical irregularity. 5-6 storey building (with additional cellar) is surrounded by courtyard and inner round balconies for each floor (Fig. 4. a,b). Northern and eastern part of the building has 5 storeys, with additional cellar and loft construction (Fig. 5), while the South and western part has 6 storeys with cellar and on the top with flat roof.

Figure 4. a,b Exterior photos of the selected building

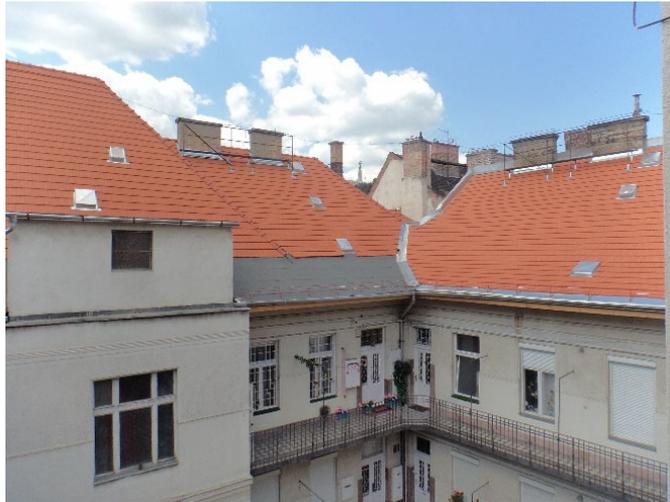
Figure 5. loft construction

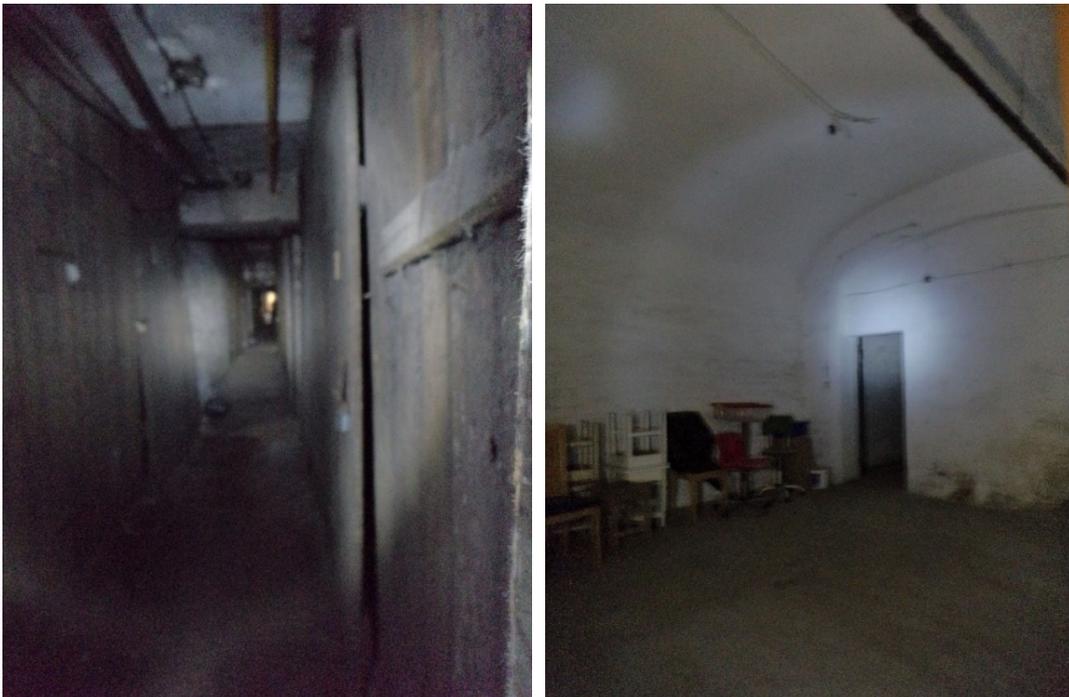
The cellar is represented as corridor system structure (Fig. 6.a) with small, separated rooms from left and right hand side. Brick arches are used as a slab (Fig. 6.b). Inside part of the cellar is dry and there is no water seepage.

Figure 6. a,b Cellar

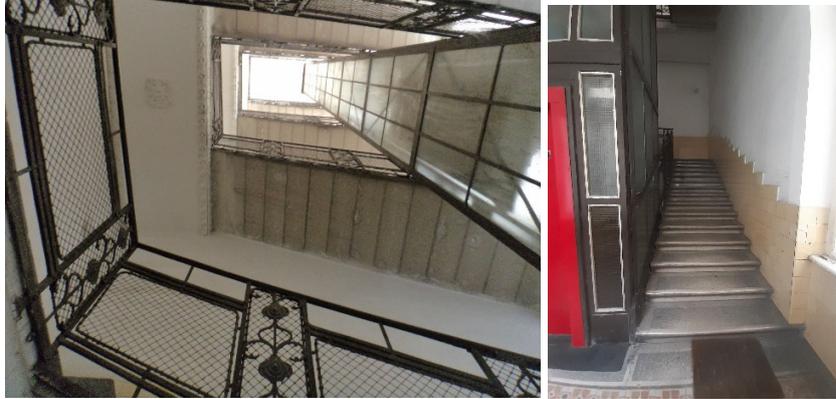
The structure has two brick masonry cores with main staircase with elevator (Fig. 7.a,b) and secondary staircase, made by stone. Last floor staircase is not in a good condition and requires more detailed investigation. There is an elevator in the corner of south eastern part.

Figure 7.a,b Internal Staircase

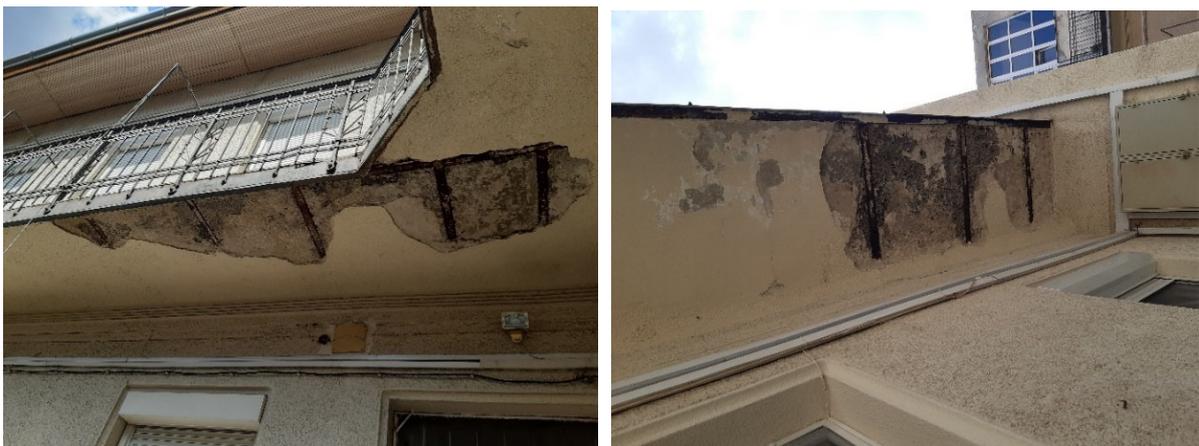
Figure 8.a,b Material loss, illustrated on the bottom part of the balconies

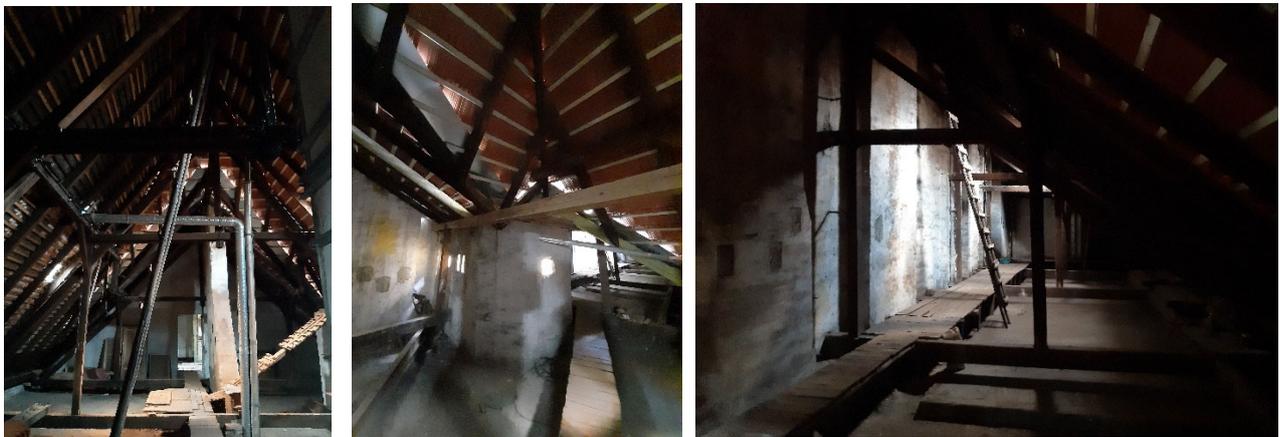
The existing building has two type of the roof construction. From southern side it is an open gable and from western side a shed roof is presented. Major part of the loft construction consists of timber beams, columns and rafters (Fig. 9.a,b,c). Maximum height of the roof is around 6.5-6.7m from the bottom. Some of the walls are continuing until the top of the roof. There are several chimney constructions, too.

Figure 9.a,b,c Loft constructions

Visual investigation of the loft constructions shows that the materials (Fig. 9.a,b,c) are relatively new, in good condition.

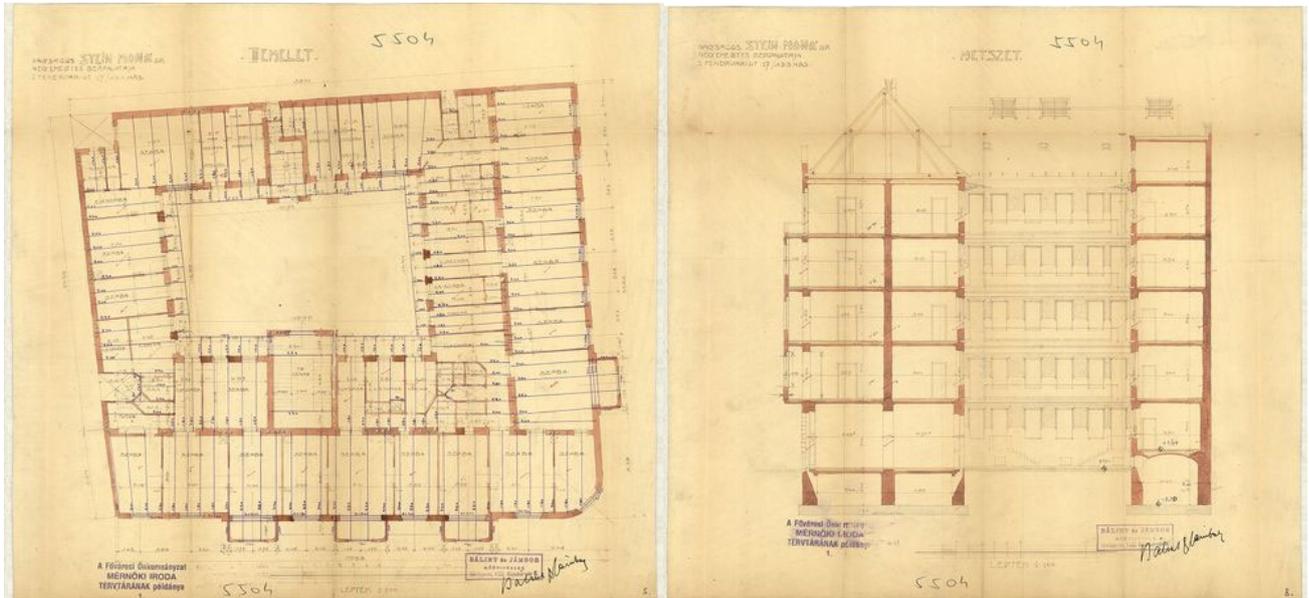
The old drawings (Fig. 17.a,b) of existing building were procured from Hungarian online archive [8] and were modified by new measurements gathered from the site survey. Several new drawings are illustrated in the research paper (Fig. 18,19,20.a,b).

Figure 17. a) Samples of the typical plan and b) vertical plan (old drawings)

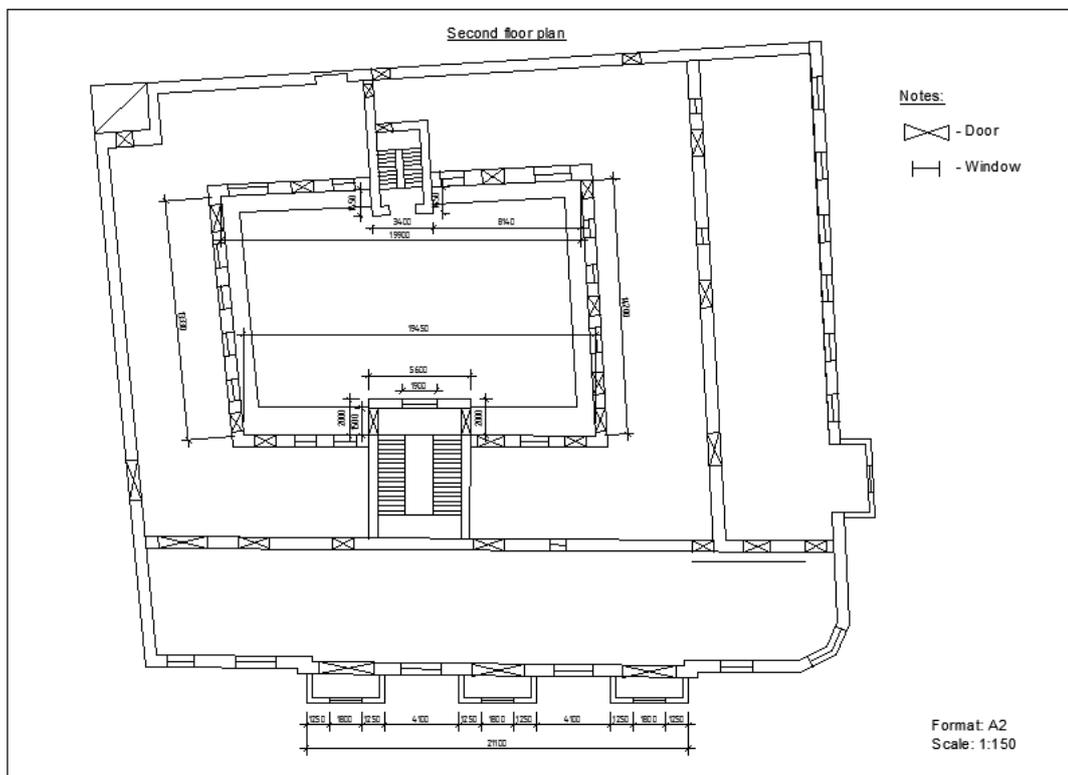
Figure 18. Sample of the walls and openings plan of typical floor (new drawing)

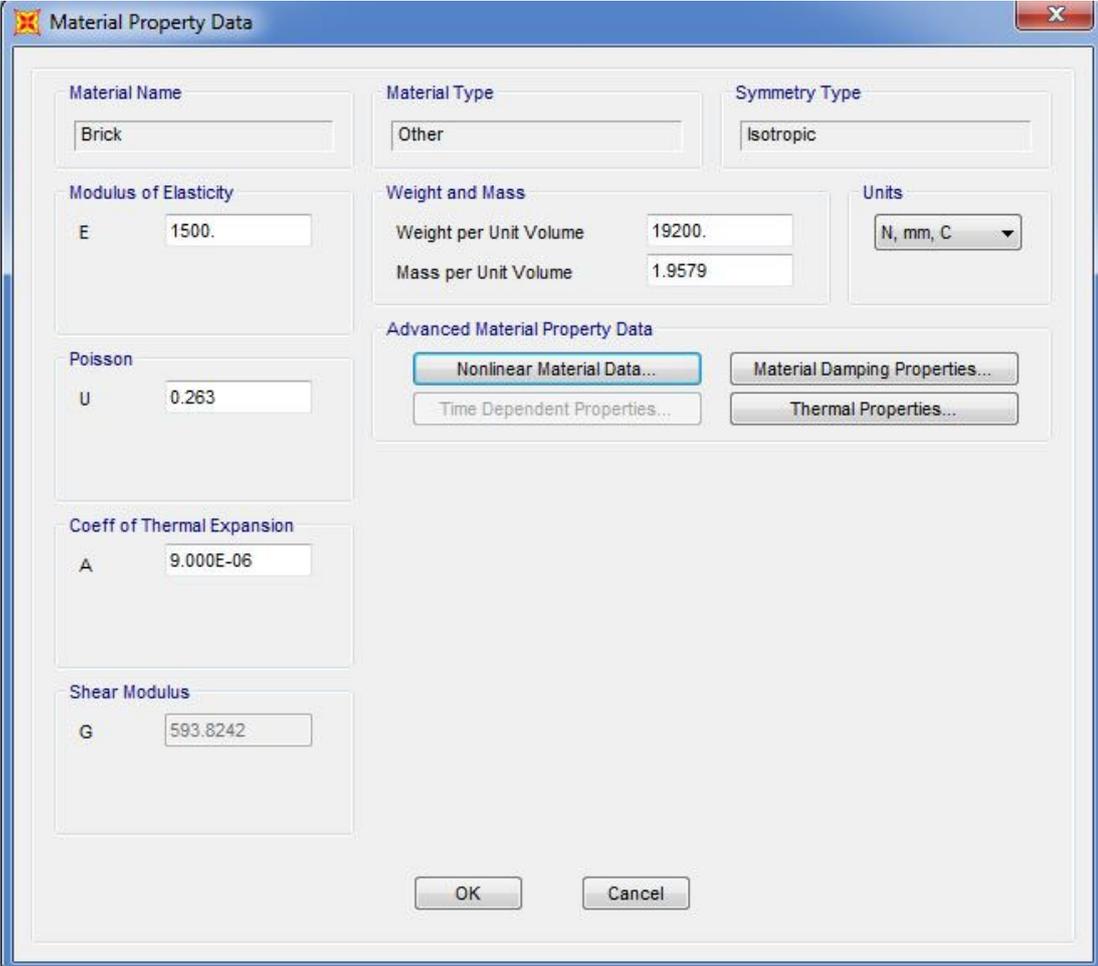
3D model of the existing building was designed in Sap2000. First step was to define material properties (Fig. 19, Fig.20)

Figure 19. Material property data

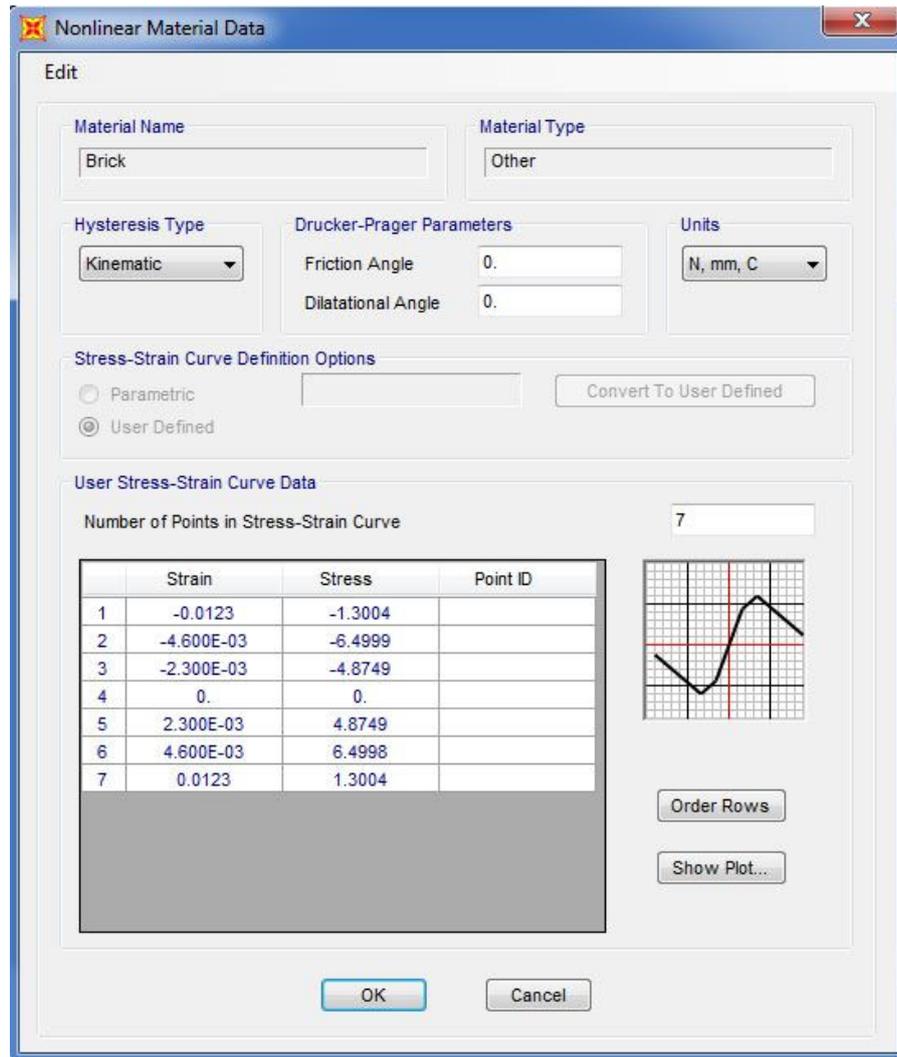
Figure 20. Nonlinear material data

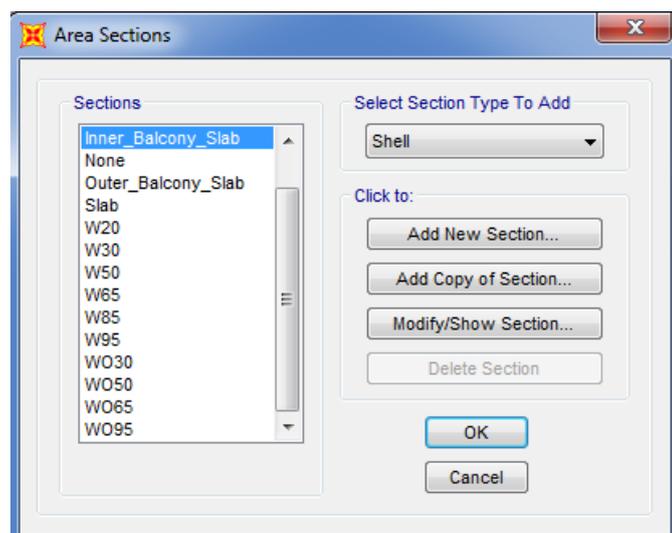
Shell elements were selected for wall sections (Fig. 21, Fig. 22).

Figure 21. List of the wall sections

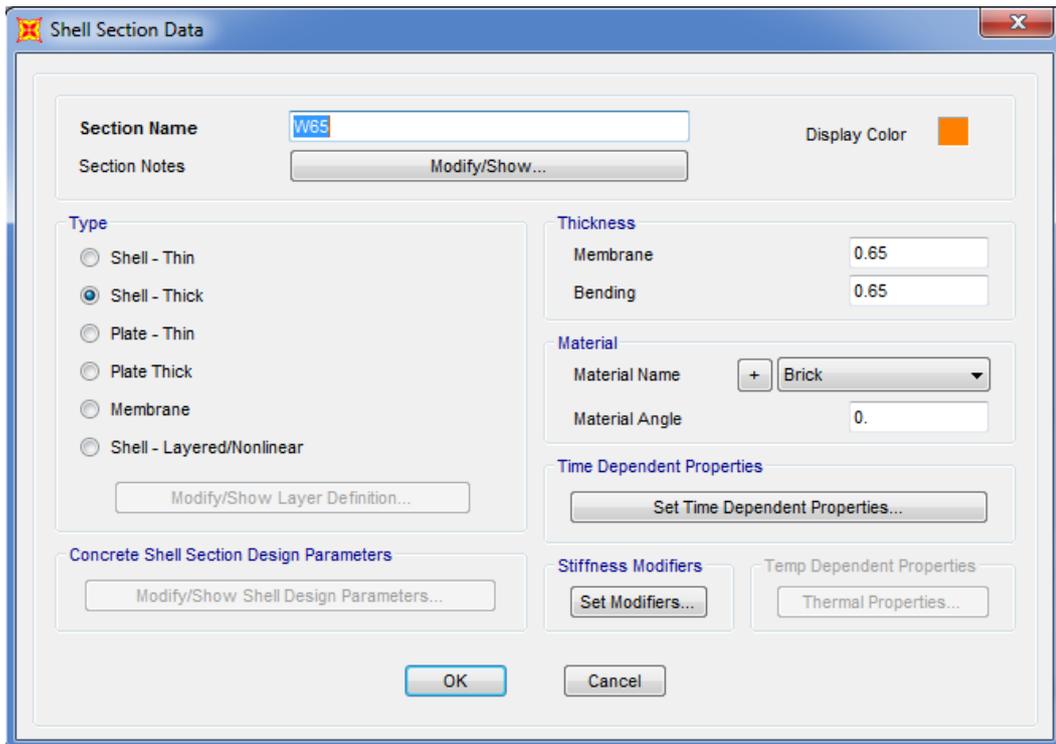
Figure 22. Shell section data for the wall with thickness 65 cm

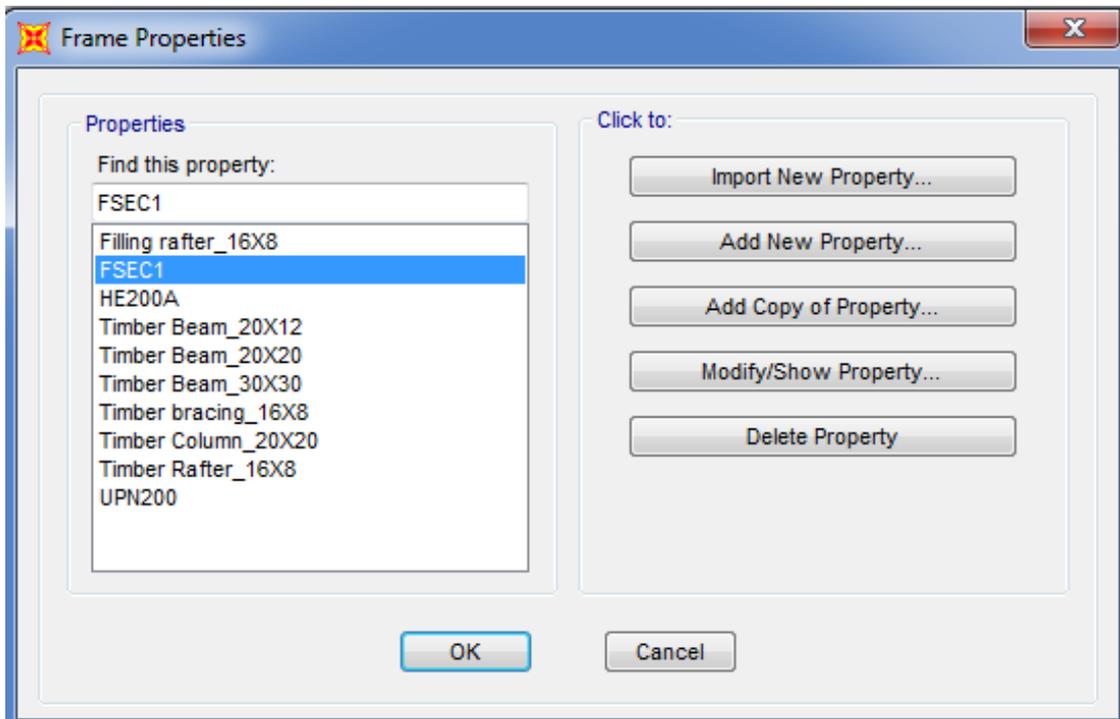
Steel beams were used on balcony edges, and for loft construction timber frame elements were defined (Fig. 23).

Figure 23. Frame properties

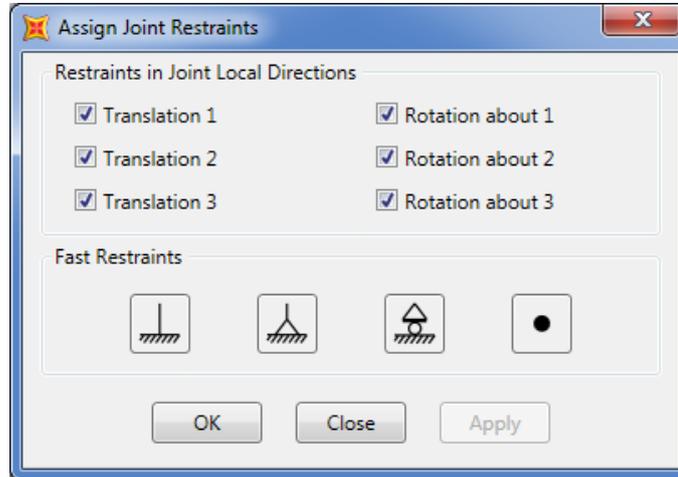
Shell elements for slab and walls were divided into 0.2 – 0.3m size finite elements. Starting points of the wall finite elements were restrained as it is illustrated on Fig. 24.

Figure 24. Joint restraints

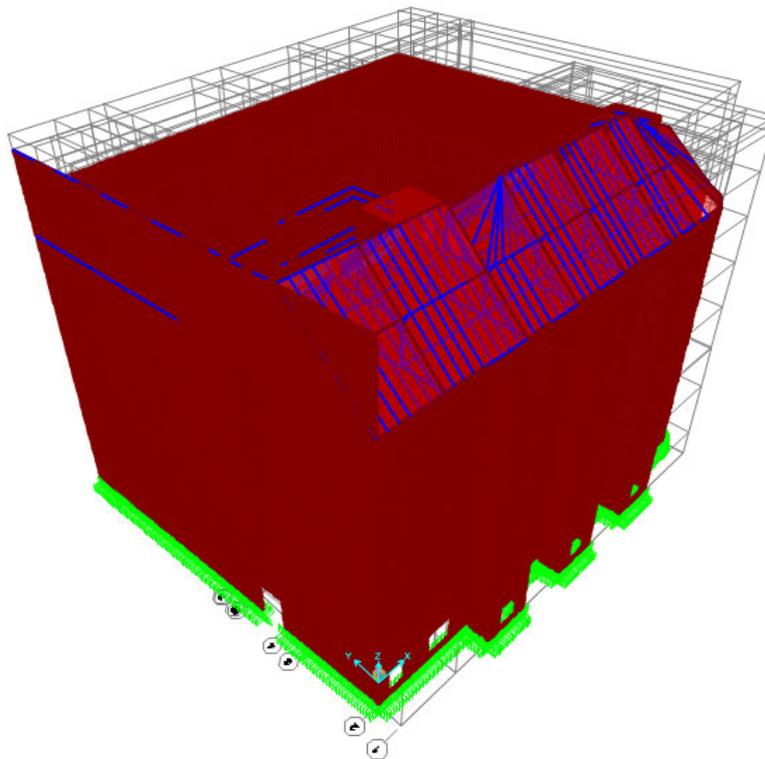
When the design of the building geometry was completed (Fig. 25), Dead, live and horizontal loads were assigned [9].

Figure 25. 3D model of the building

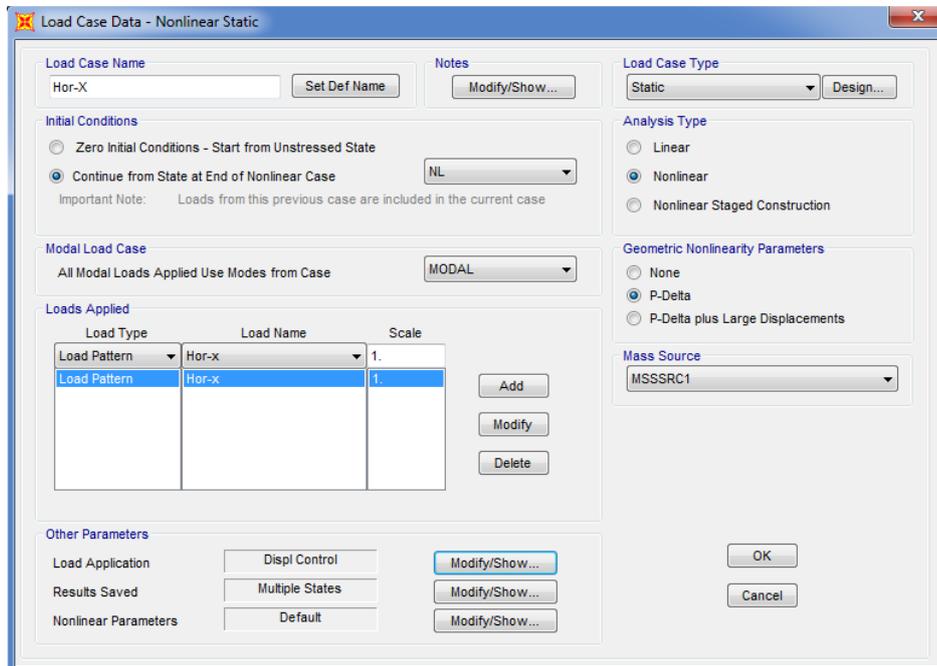
Nonlinear static load case was defined for nonlinear static analysis, which combines dead and live loads. Then the horizontal load case was modified for nonlinear static analysis.

Figure 26. Horizontal load case modified for nonlinear static analysis

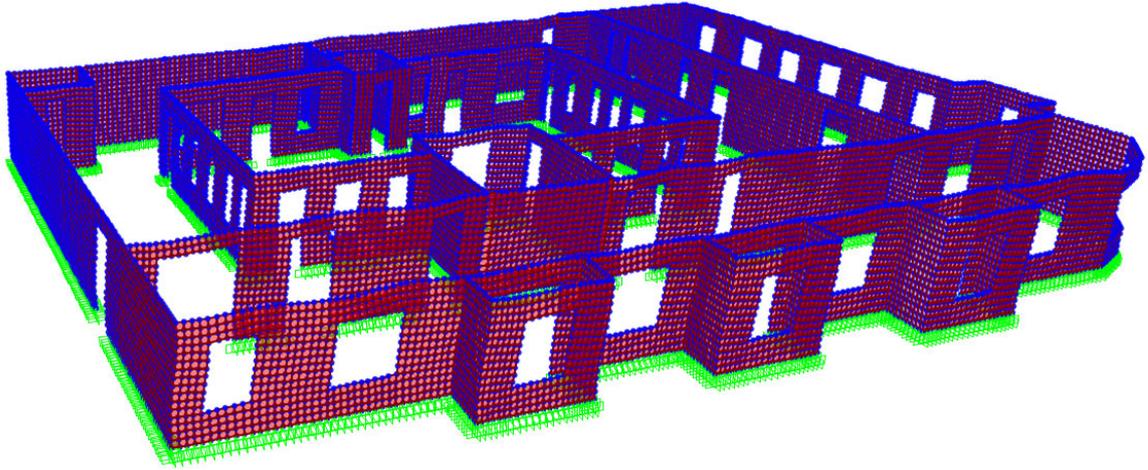
To calculate the numerical model of the whole building by nonlinear static pushover analysis requires too much time for masonry building with a large volume. Alternative decision was made to calculate single floor separately and increase the vertical and horizontal loads for each floor (Fig. 27, 28, 29.a,b, Table 6).

Figure 27. Deformed shape of the single floor walls

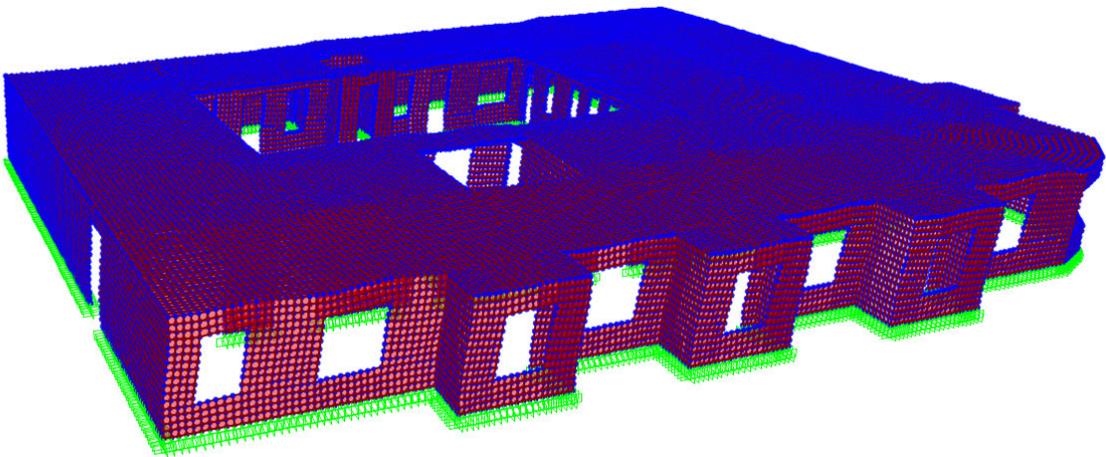
Figure 28. Deformed shape of the single floor walls and slab

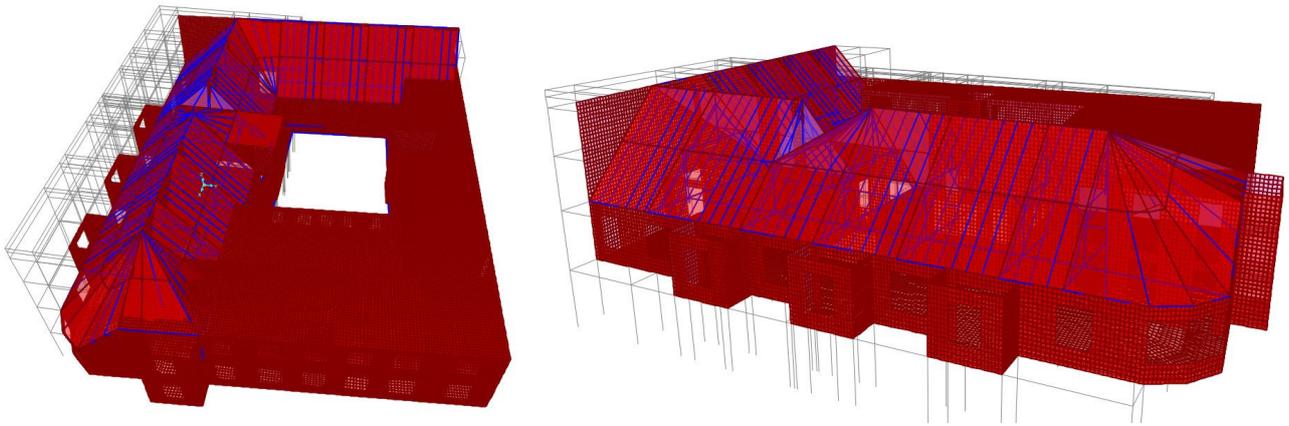
Figure 29.a,b 3D model for last floor and loft construction

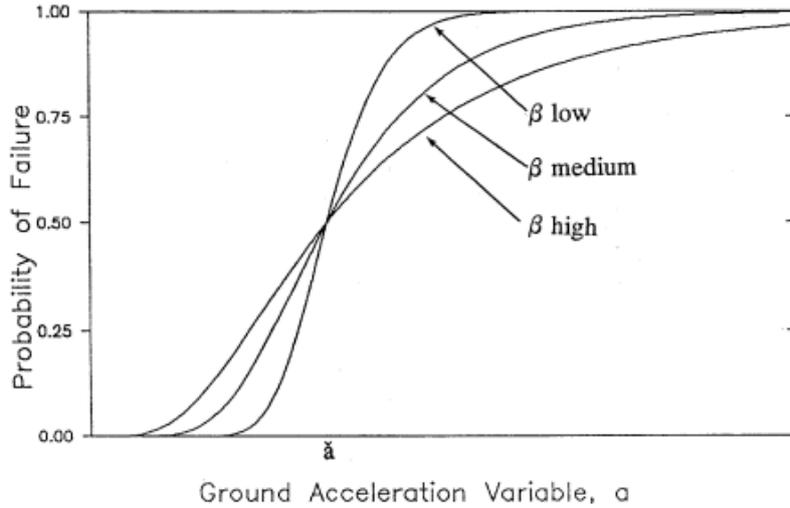
Figure 30. Fragility curve based on the lognormal distribution [11]

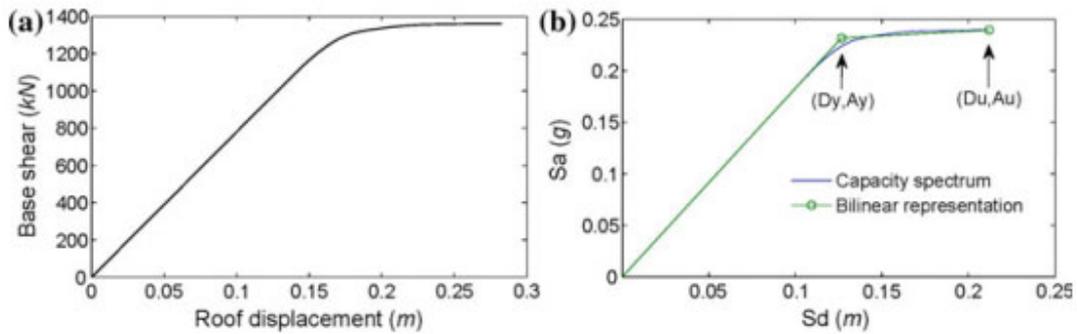
In case of numerical analysis, Nonlinear static pushover analysis is required to use. The capacity curve expressed by pushover analyses has to be converted into a bilinear curve. Limit- displacement values can be identified (Fig. 31).

Figure 31. Capacity curve (a) and capacity spectrum (b) obtained from the deterministic APA [12]

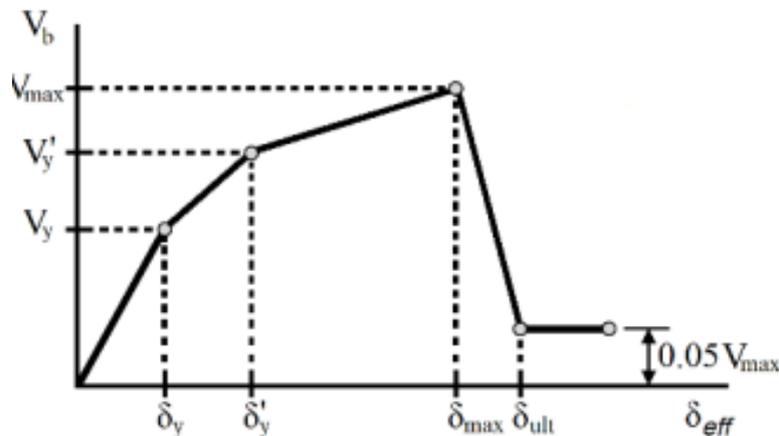
To use the illustrated model (Fig. 32) depends on both the description of the damage states on the F - δ curve, the placement of the ultimate point (δ_{ult} , F_{ult}) and the importance of the residual strength of the wall [?].

Figure 32. Idealizations of the F - δ backbone curve for masonry walls.

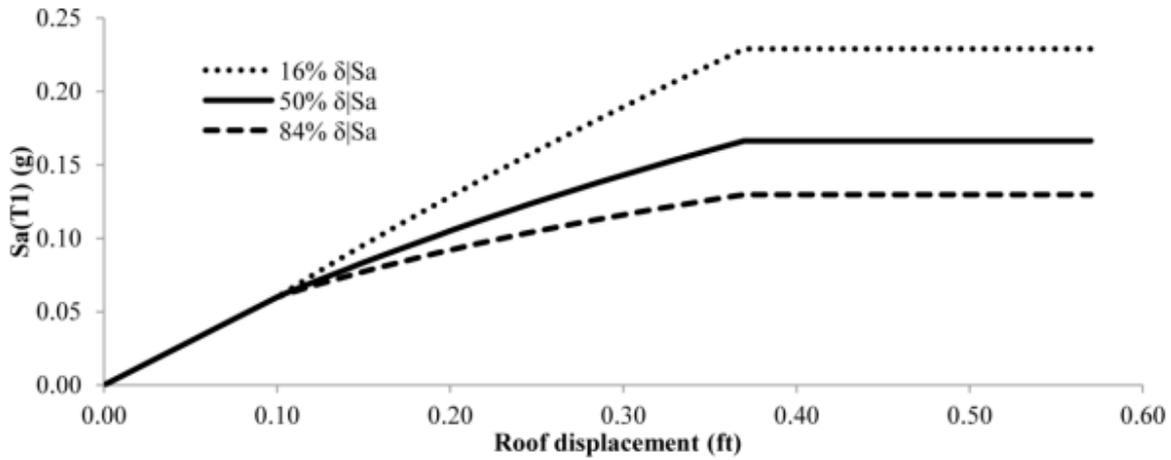
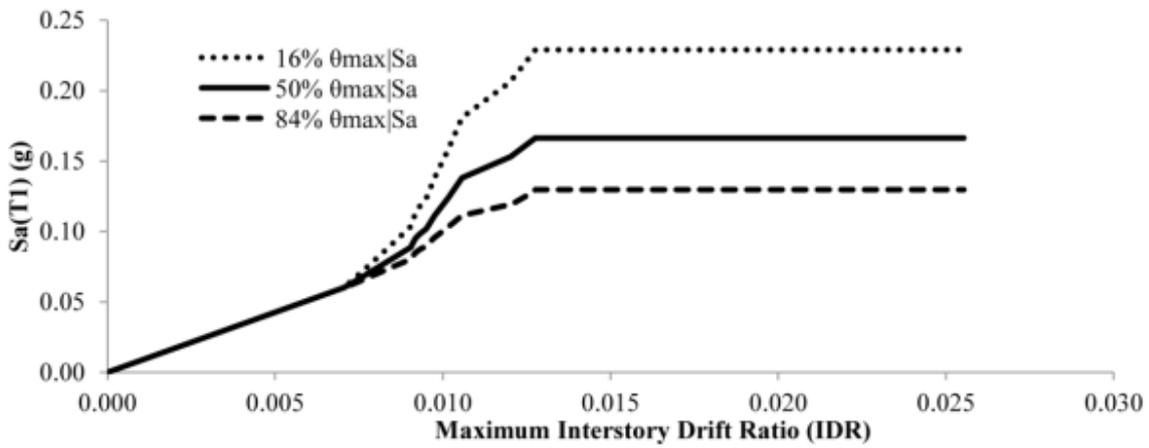
(a) Sa(T1)(g) vs Roof displacement

(b) Sa(T1)(g) vs Maximum Interstorey Drift Ratio

Figure 33. SPO2IDA-predicted IDA fractiles for the equivalent SDoF system (a) Sa(T1)(g) vs Roof displacement, (b) Sa(T1)(g) vs Maximum Interstorey Drift Ratio [14]

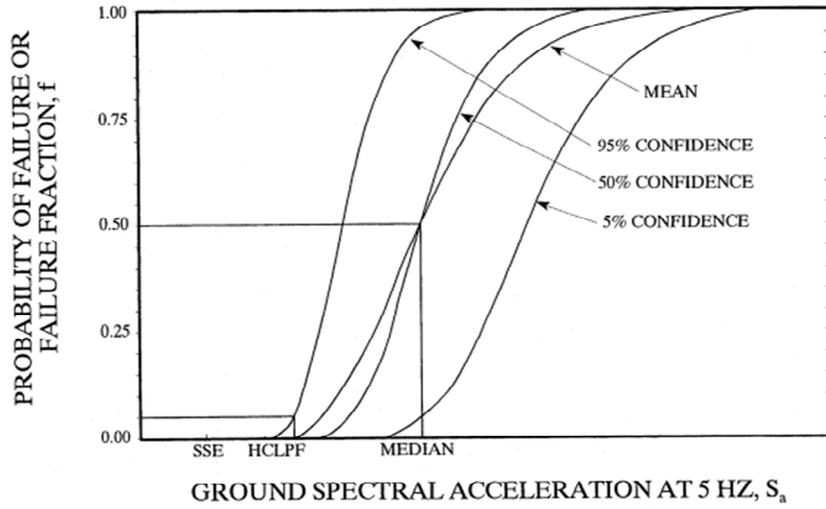
Figure 34. Illustration of fragility curves [11]

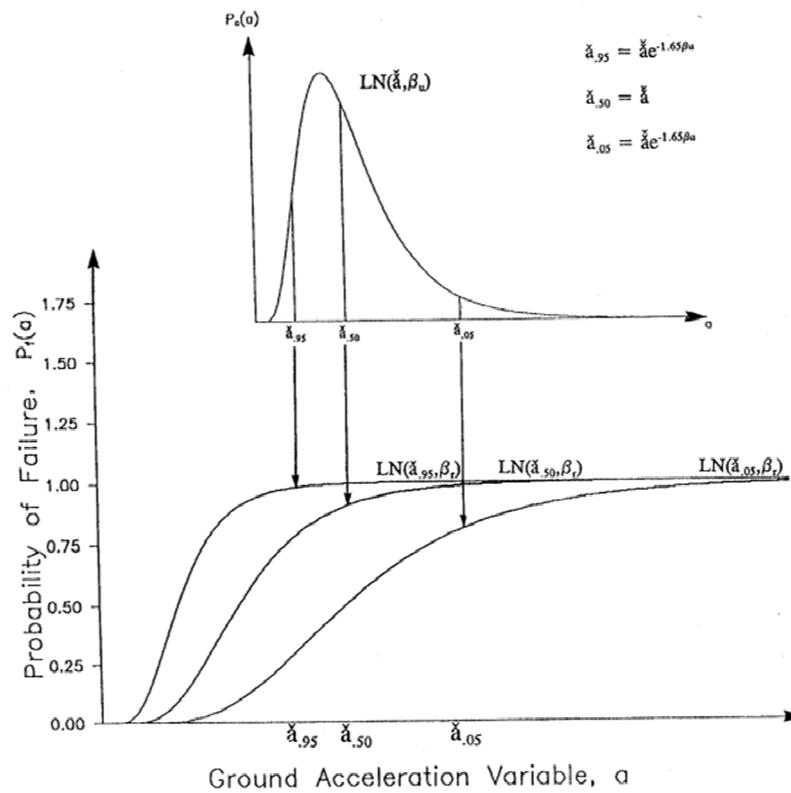
Figure 35. Family of fragility curves at 95%, 50% and 5% confidence levels [11]

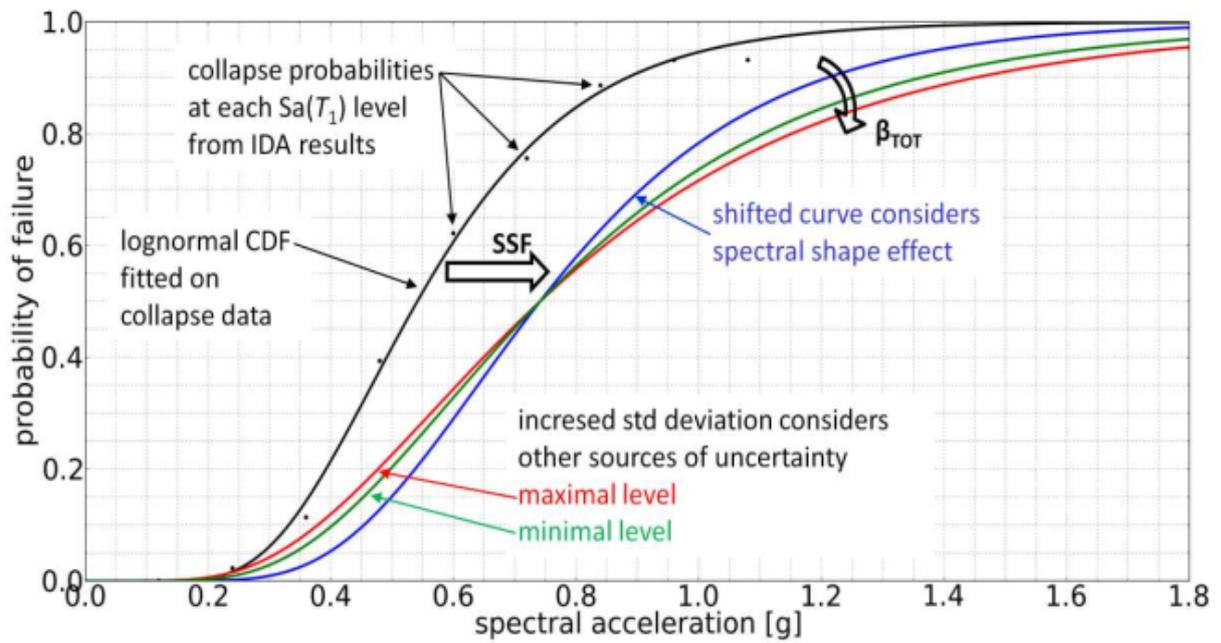
Figure 36. Fragility curve, conditional probability of failure [15]

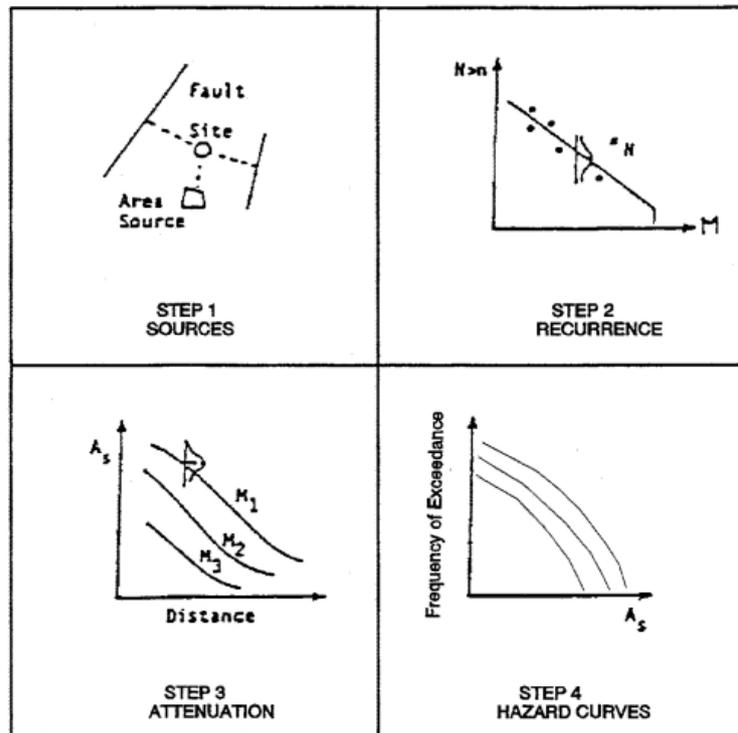
Figure 37. Seismic hazard analysis steps [11]

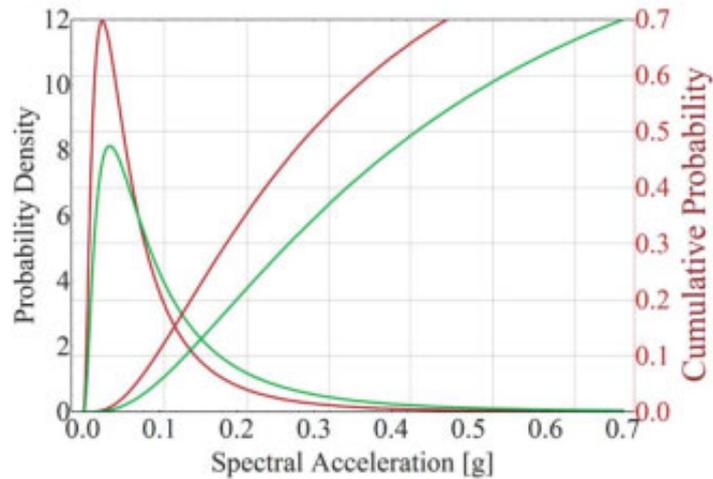
Hazard curve is given as a probability density as a function of special acceleration (Fig. 38). It reflects the time-dependence and frequency of occurrence of the action, that depends on the location. It is an action-specific feature [15].

Figure 38. Hazard curve, PDF and CDF for two sites (Kosovo (green) and Italy (red; PGA = 0.2 g) [15]

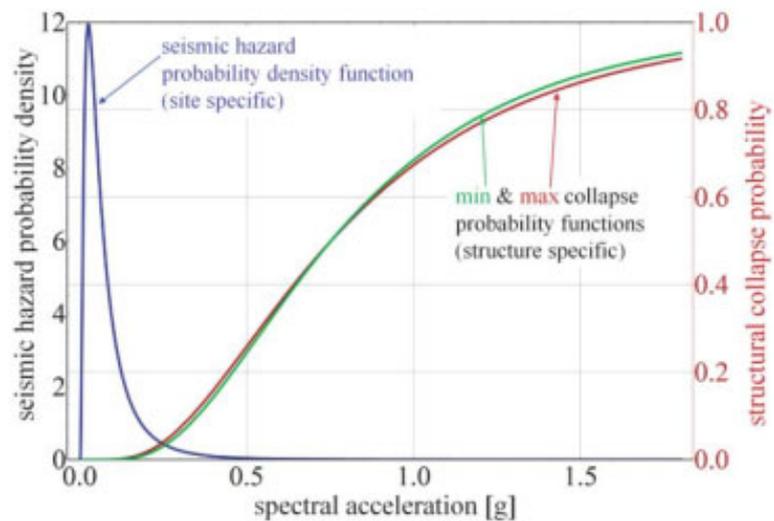
Figure 39. Fragility and hazard curves [15]
