Budapest University of Technology and Economics
Department of Geodesy and surveying

Comparison Analysis of Point Cloud Techniques Used for Developing a BIM System

Author: Beka Kakabadze
Supervised by: Dr. Lóránt Földvály
Máté Lehoczky

2021

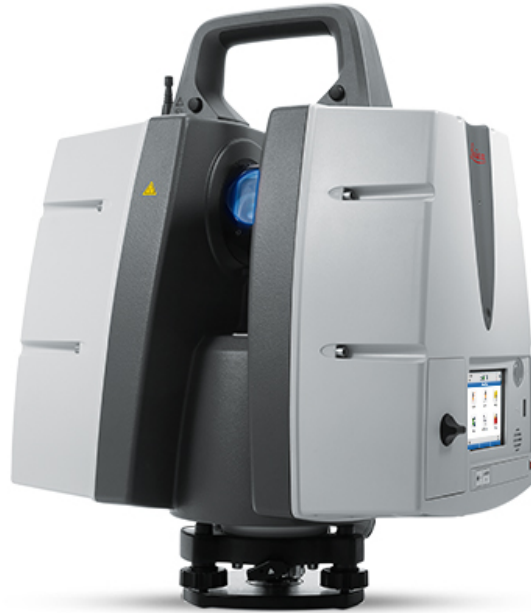
Figure 1. Leica ScanStation P40, Leica GeoSystems

Leica ScanStation P40 is a high-definition 3D laser scanner, designed and manufactured by Leica Geosystems. This instrument is based on the Time-of-Flight (TOF) and WaveForm Digitizer (WFD) distance calculation methods. The TOF technology uses the time it requires for an emitted light pulse to hit the surface and return to the scanner. Leica no longer uses only TOF technology in their instruments, since the method lacks high accuracy. Instead, the TOF and phase-shift methods are combined to create a much more precise way of surveying. This technology is called WaveForm Digitizer (WFD). It is important to note, that the WFD is still primarily a TOF type, featuring some benefits of phase-shift technology. As a result, Leica ScanStation P40 has extensive abilities.

Table 1. Specifications of Leica ScanStation P40

Range accuracy	1.2mm + 10ppm over full range
Angular accuracy	8" horizontal; 8" vertical
3D position accuracy	3mm at 50m; 6mm at 100m
Wavelength	Invisible: 1550nm / Visible: 658nm
Scan rate	Capable of 1,000,000 points per second
Range	Up to 270 meters
Field of view	Horizontal: 360° / Vertical: 290°

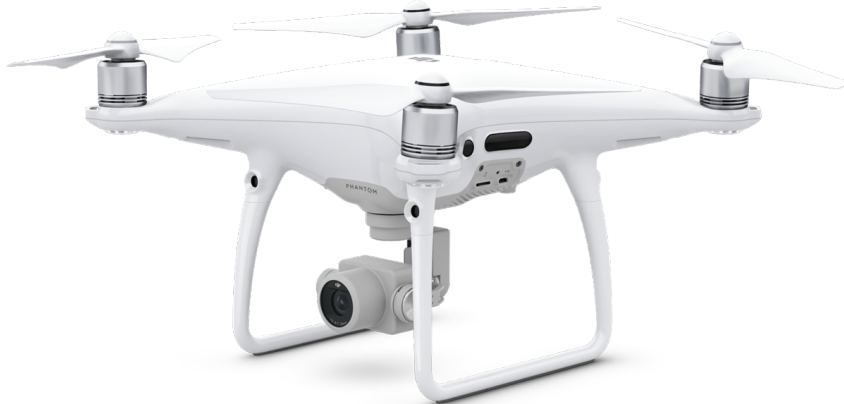
Figure 2. DJI Phantom 4 Pro UAV

The DJI Phantom 4 Pro UAV was used to survey the parts of the building that are not visible from the ground. Yet, the entire facade of the building was covered using the

UAV. The drone is equipped with a 1 inch, 20-megapixel sensor, capable of recording 4K footage. It has forward, backward, and downward vision systems, as well as a flight range of up to 7km. The UAV can capture the most remote parts of the building in detail.

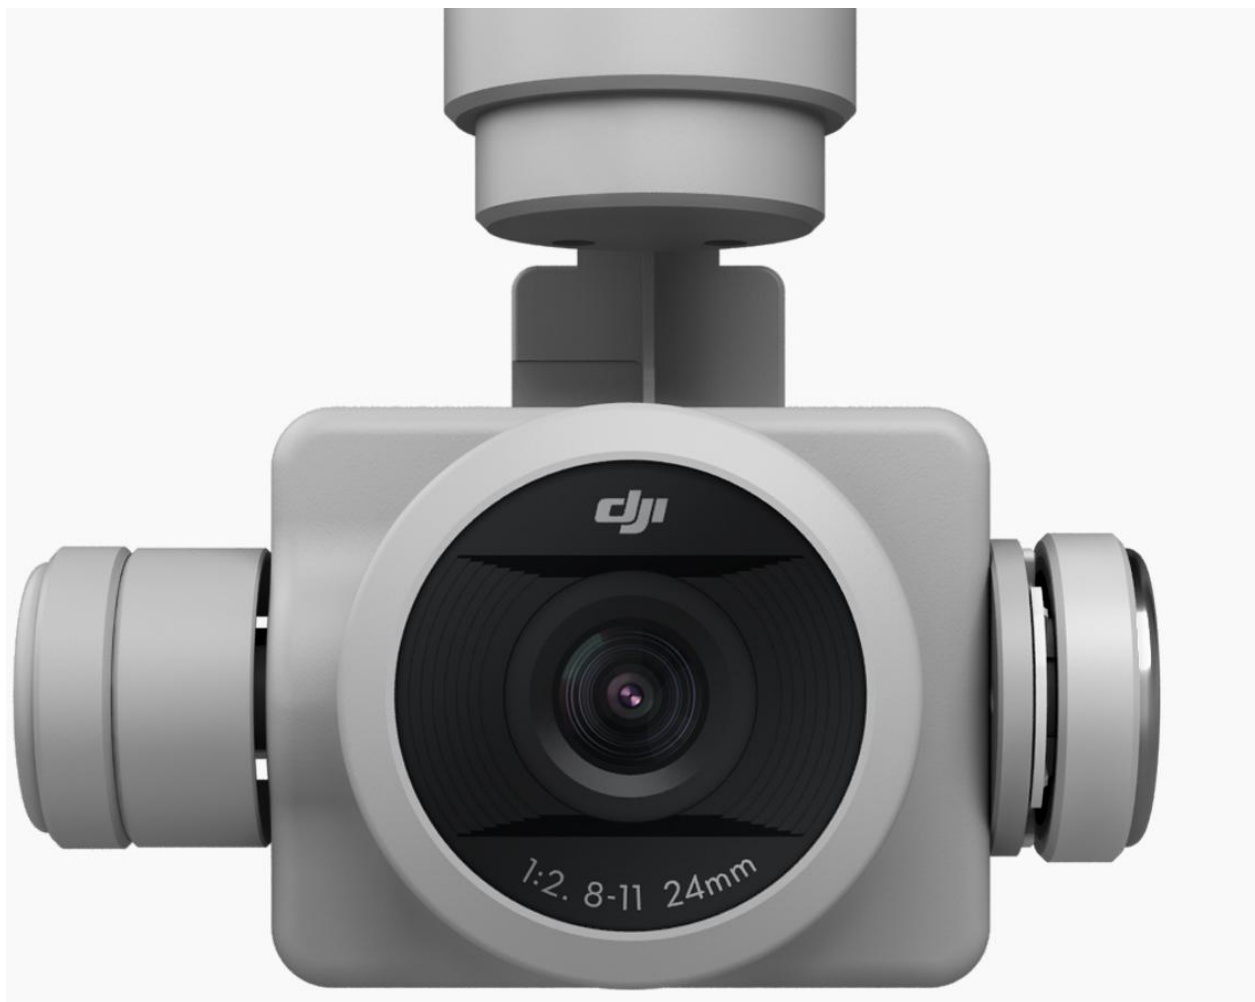
Figure 3. 1 inch, the 20-megapixel camera of DJI Phantom 4 Pro

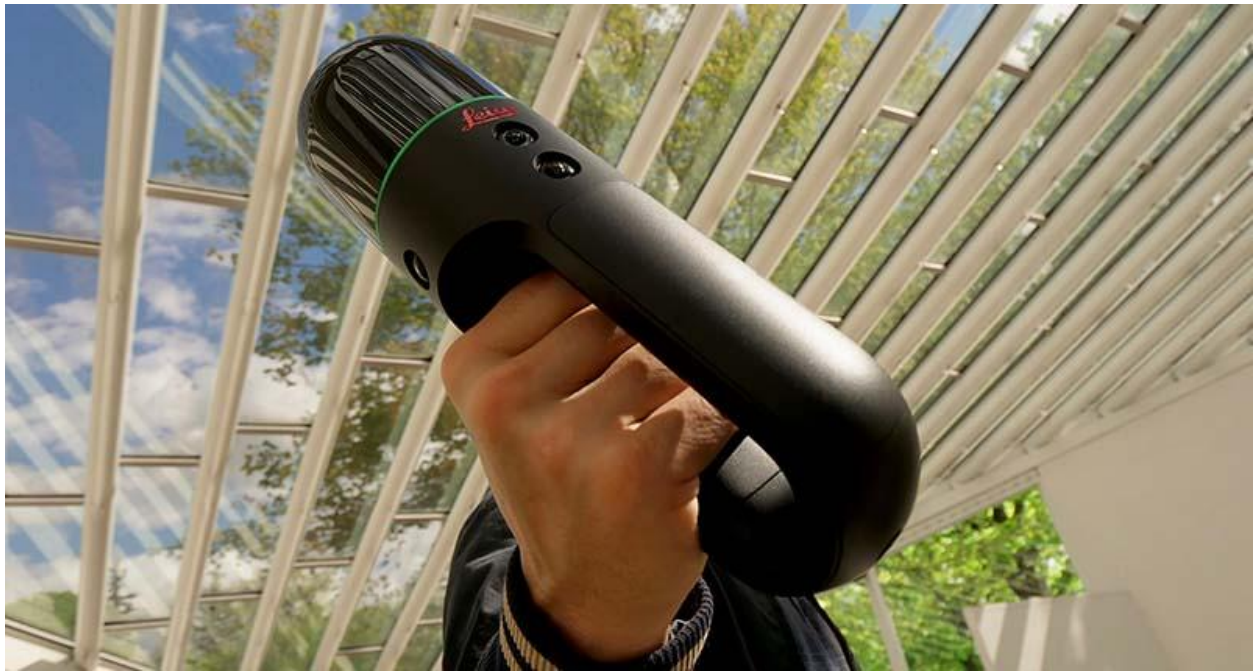
Figure 4. Leica BLK2GO Handheld Imaging Scanner

The entire interior of the building was surveyed using the Leica BLK2GO handheld scanner. The scanner is wireless and fast. It has the ability to scan under and over objects throughout space. The instrument automatically creates 3D point clouds during

motion. Its SLAM spatial awareness technology enables the instrument to locate itself precisely inside of the building. As a result, Leica's scanner recognizes spaces it has already covered. Due to the scanner's fast and convenient nature, the survey of the interior was done in an extremely short timeframe - approximately 2 hours. On the contrary, interior surveys performed with traditional methods can take much longer, while being more complex to execute.

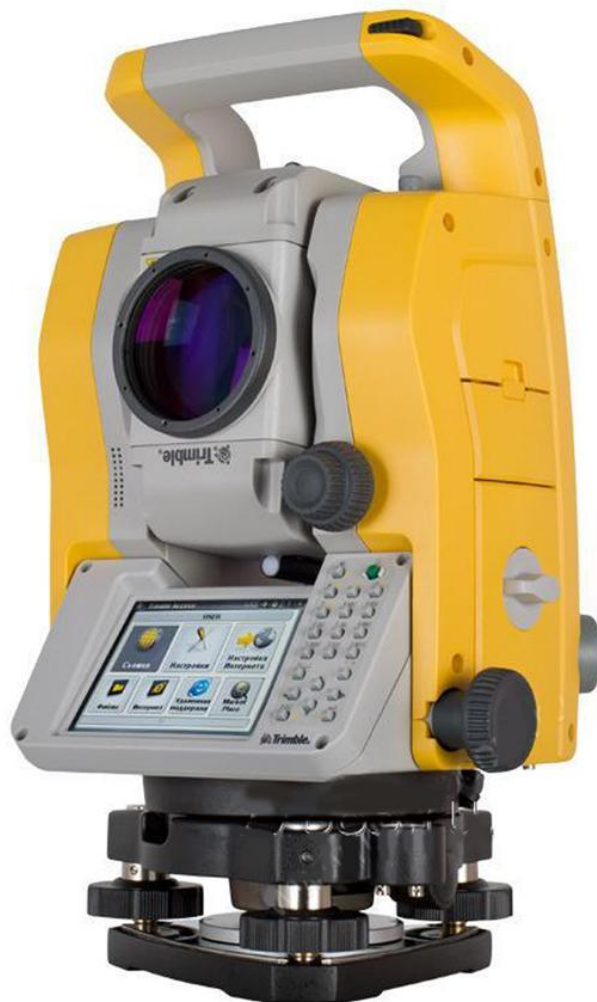
Figure 5. Trimble M3 3" Total Station

Reference points of the building's facade were surveyed with Trimble M3 3" total station. It is a mechanical total station, featuring both traditional prism reflector (PR) and direct reflex (DR) technologies. The latter ensures that certain hard-to-reach points on the facade, such as window and door corners, or parts of the roof, can be accessed. The instrument is equipped with Nikon optics, as well as software provided by Trimble.

Accuracy in prism mode	$\pm(3 \text{ mm} + 2 \text{ ppm})$
Direct Reflex mode	$\pm(5 \text{ mm} + 2 \text{ ppm})$
Range in prism mode	Up to 5000 meters
Range in Direct Reflex mode	Up to 210 meters

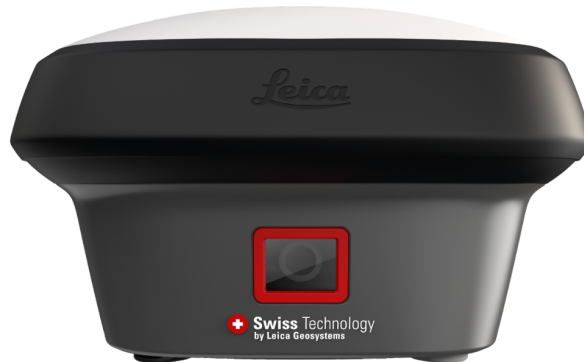
Figure 6. Leica GS18 I GNSS RTK Rover

Leica GS18 I GNSS RTK survey-grade rover was used for locating station points. The instrument has a 20Hz position update rate, making it particularly accurate and responsive.

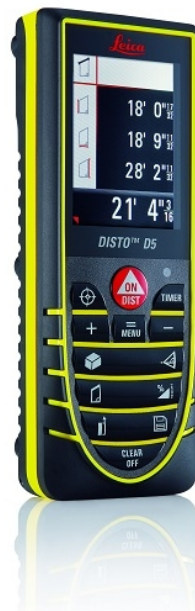
Figure 7. Leica Disto D5 laser measure

Measurements of the building's interior were performed using Leica's Disto D5 laser measure. The instrument is equipped with a built-in tilt sensor and a digital video point finder. It is able to measure distances up to 100 meters without a target plate, or even up to 200 meters with an appropriate target plate. The laser pinpoint accuracy is ± 1.0 mm.

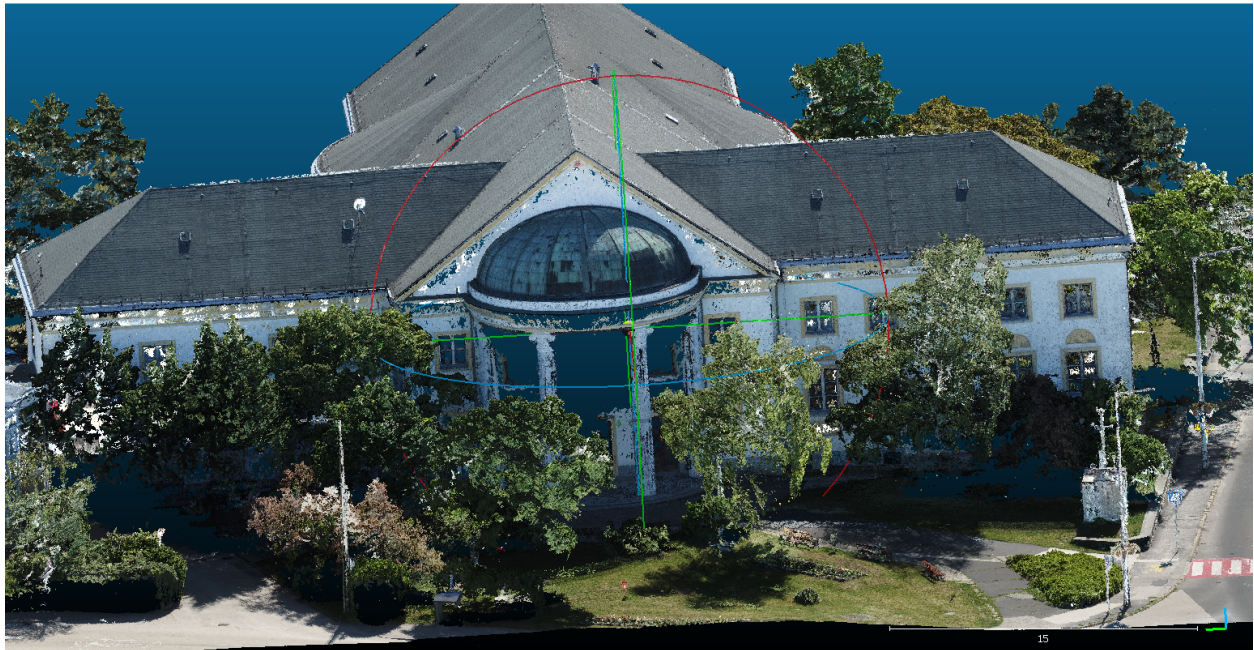
Figure 16. The western facade of the building as seen in the DJI Phantom 4 Pro point cloud

The precision and density of the point cloud are particularly good in the upper parts of the building, including all parts of the roof. However, parts of the building's facade with columns, trees, and other solid objects in front of them are poorly represented in the point cloud. As a result, the dataset (Table 5) given below does not include 6 points from the facade.

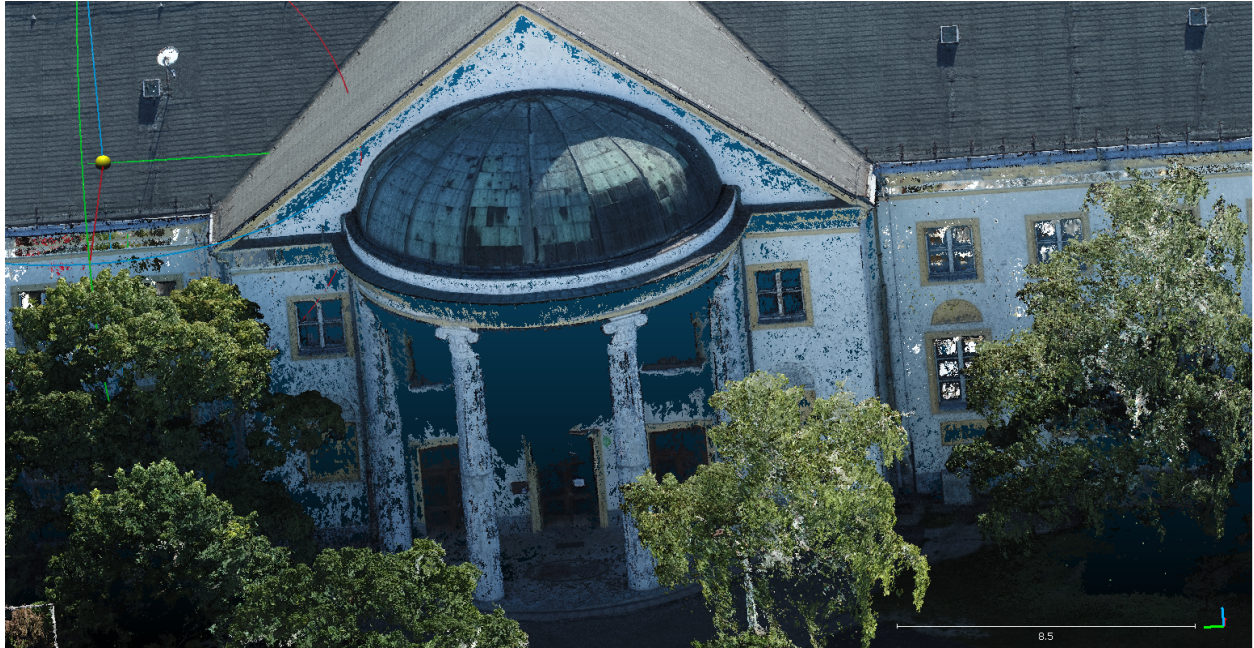
Figure 17. The focus area of the western facade of the building as seen in the DJI Phantom 4 Pro point cloud

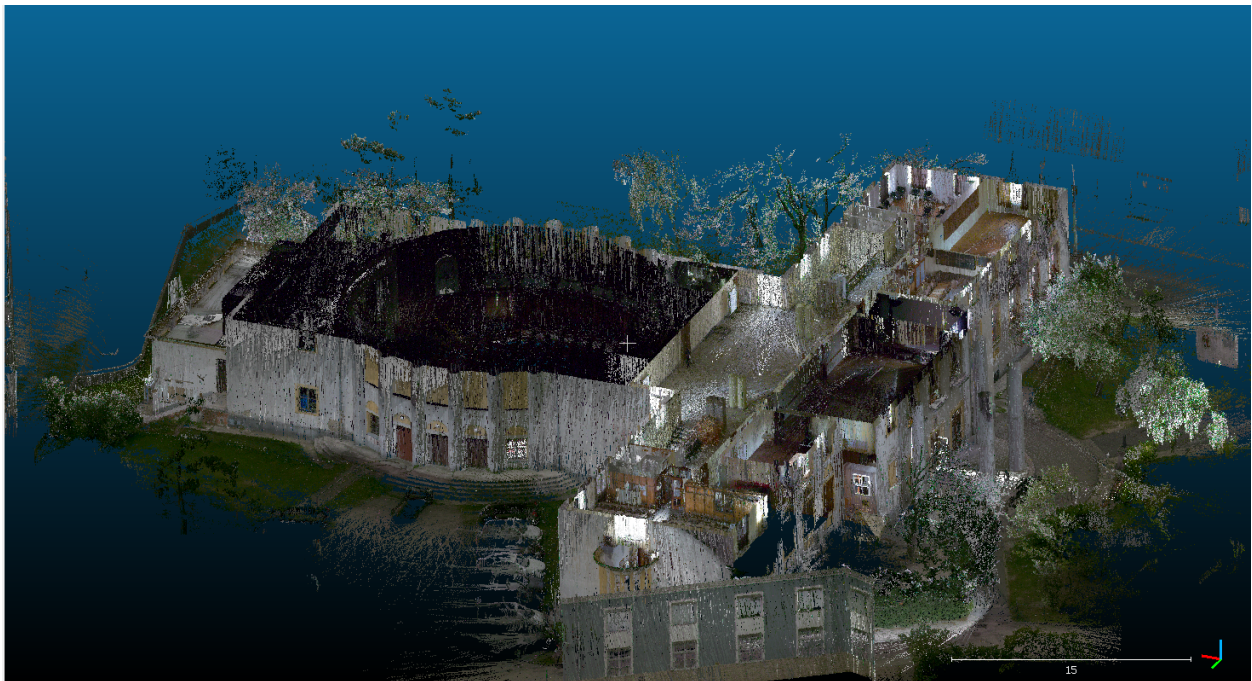
Figure 21. Section of the first floor of the building as seen in the Leica BLK2GO point cloud(RGB)

The wireless handheld laser scanner surveyed the entire interior of the building within a short time frame of 2 hours. The Point Cloud features a detailed representation of all floors of the building, including the basement, big and small spaces. The distances chosen for this research were measured using Cloudcompare's "measure" tool, which allows for distance measurements between any two points.

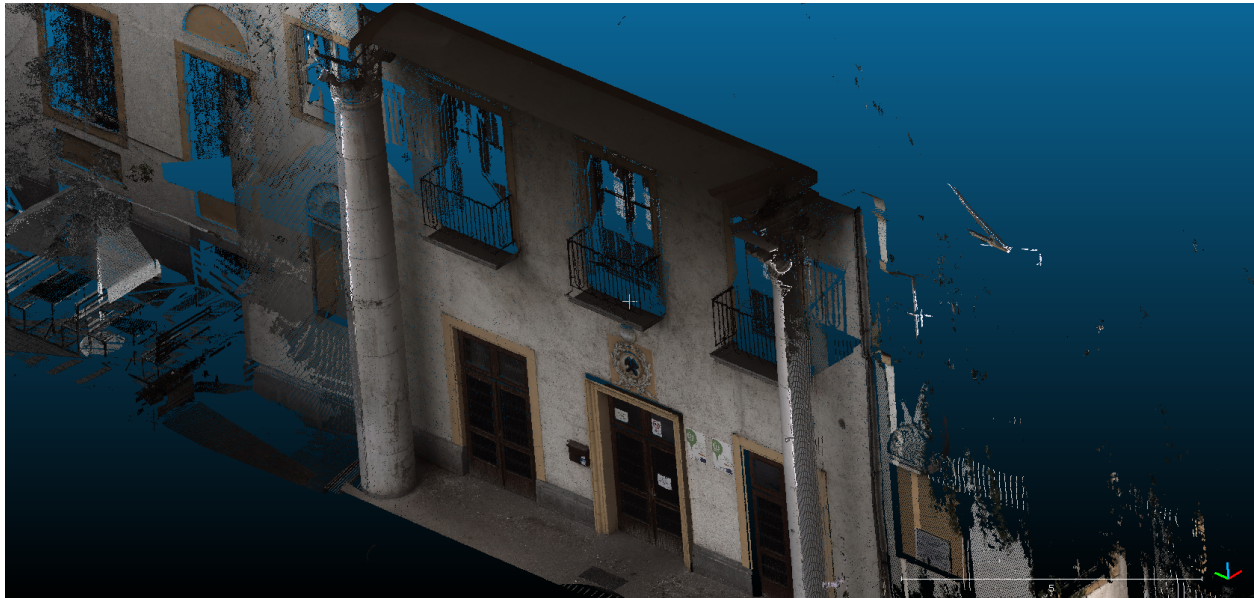
Figure 28. The view of the facade that offers a better perspective over balconies and their railings as seen in the Leica P40 point cloud (RGB)

Point number 11 has some of the highest errors on the dataset. At first, it was assumed that the total station measurement of this point was misleading, affected by errors. However, the same point in the UAV has much higher accuracy. The area around point number 11 has high intensity. Yet, the density of points is low, while the point cloud is missing big parts of the wall. These factors might have led to an error when selecting the point in the point cloud.
